DOT/FAA/CT-94/120

Evaluation of Retro-Reflective Beads in Airport Pavement Markings

December 1994

Final Report

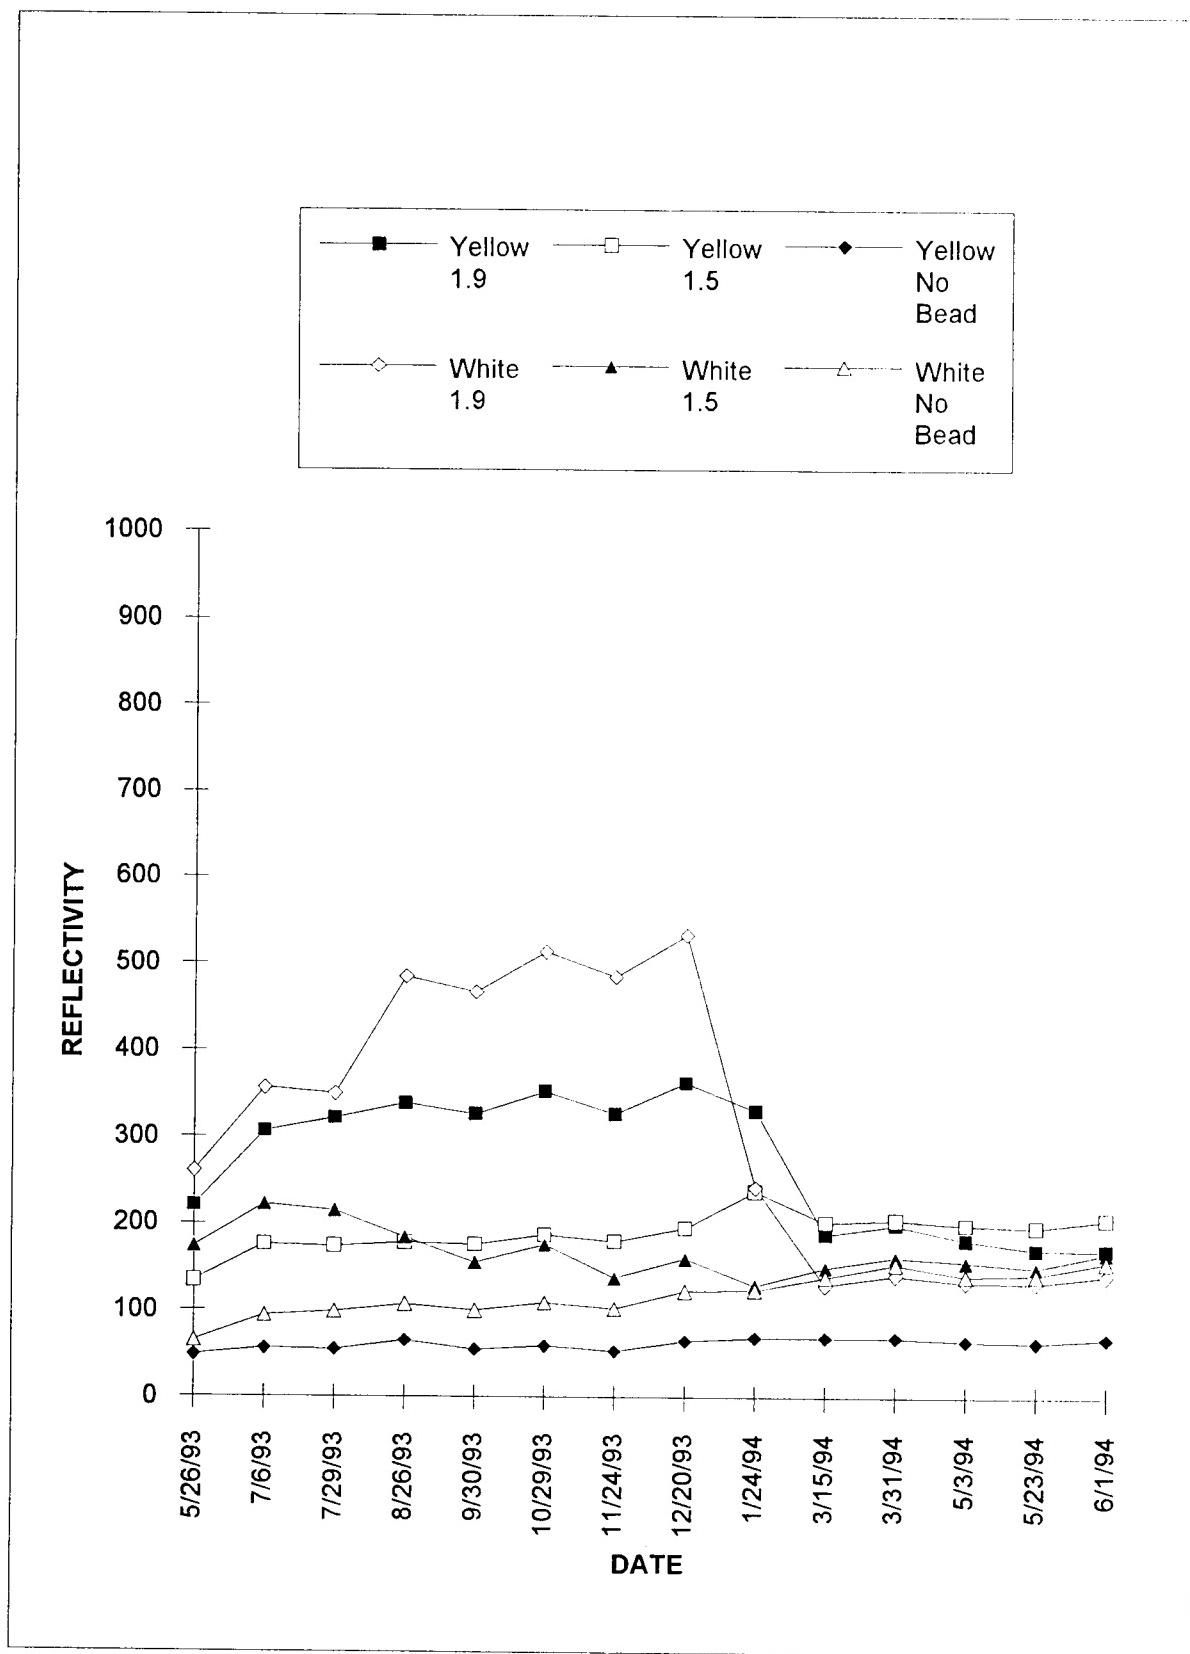
FIGURE A-18. ATLANTIC CITY - MORTON DURA-STRIPE - ASPHALT

* Readings were unavailable due to the failure of the paint material.

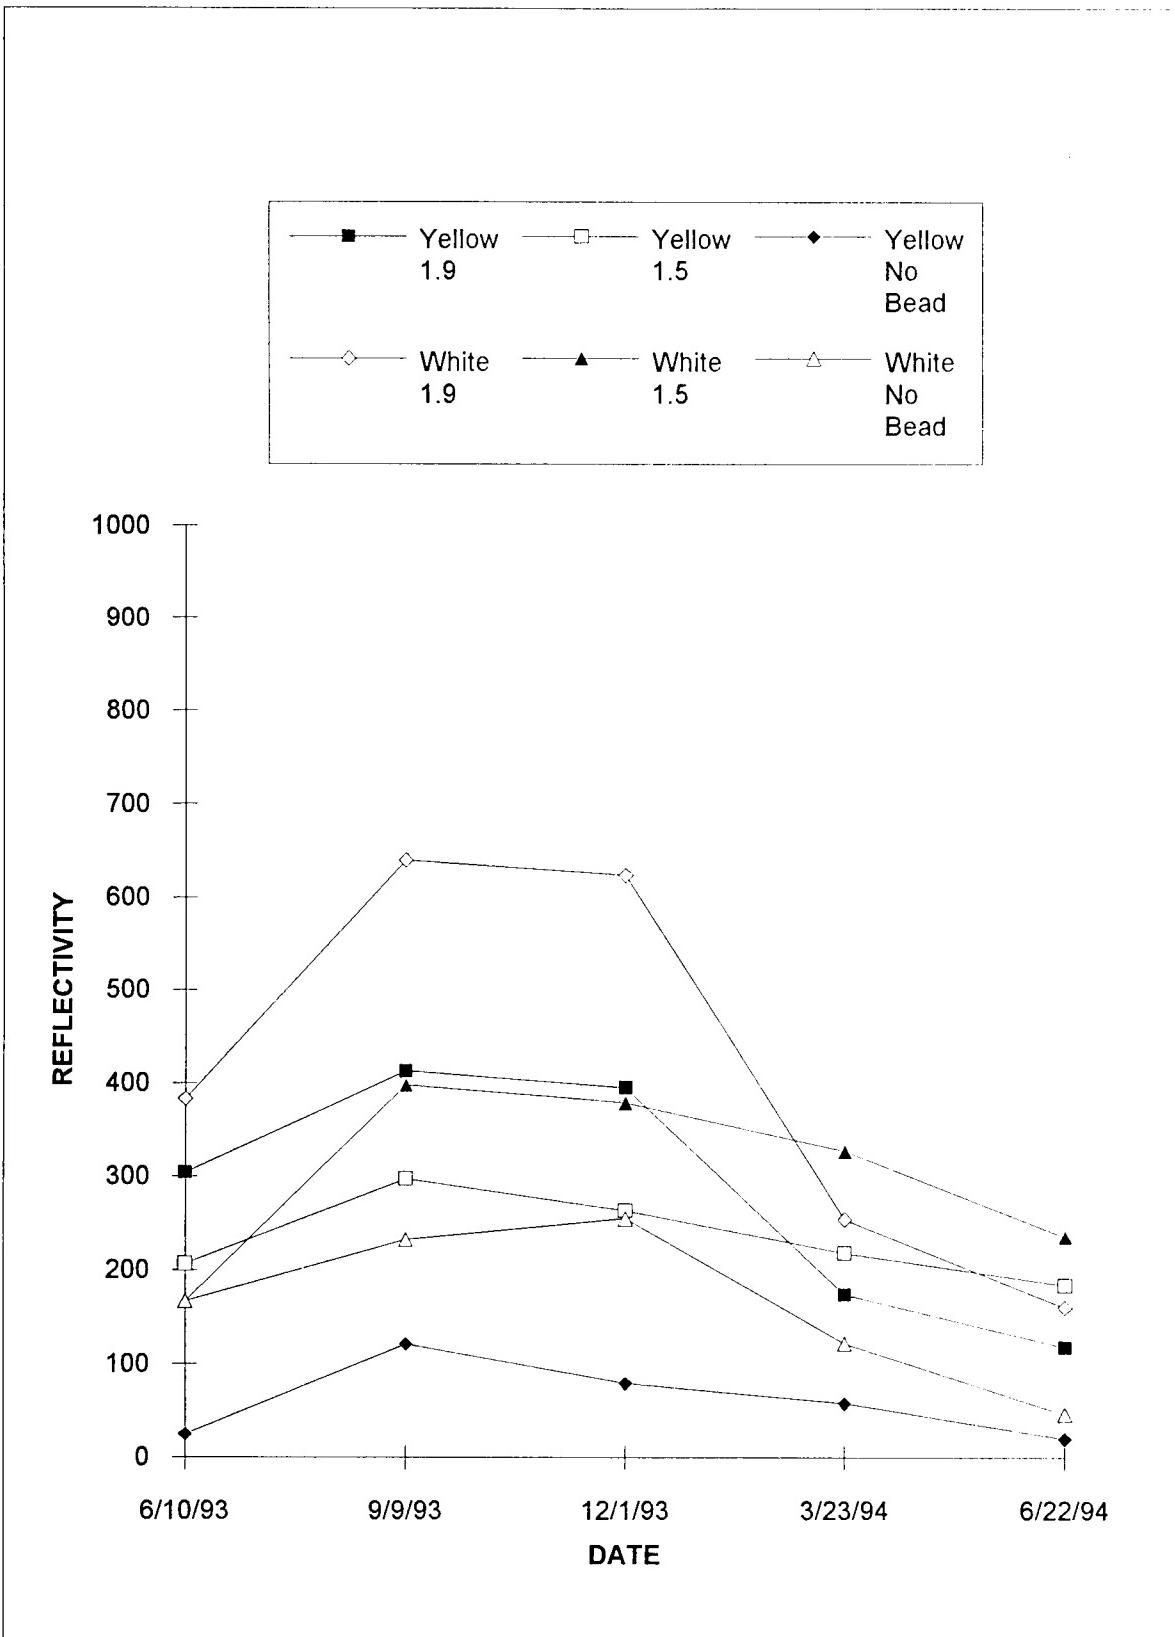
FIGURE A-20. PITTSBURGH - POLY-CARB - CONCRETE

*Readings were unavailable due to the failure of the paint material.
